MONONAME 819 DAM  
CAPE GIRARDEAU COUNTY, MISSOURI

MISSOURI INVENTORY NO. 30211

PHASE I INSPECTION REPORT  
NATIONAL DAM SAFETY PROGRAM

PREPARED BY: ST. LOUIS DISTRICT CORPS OF ENGINEERS  
FOR: GOVERNOR OF MISSOURI

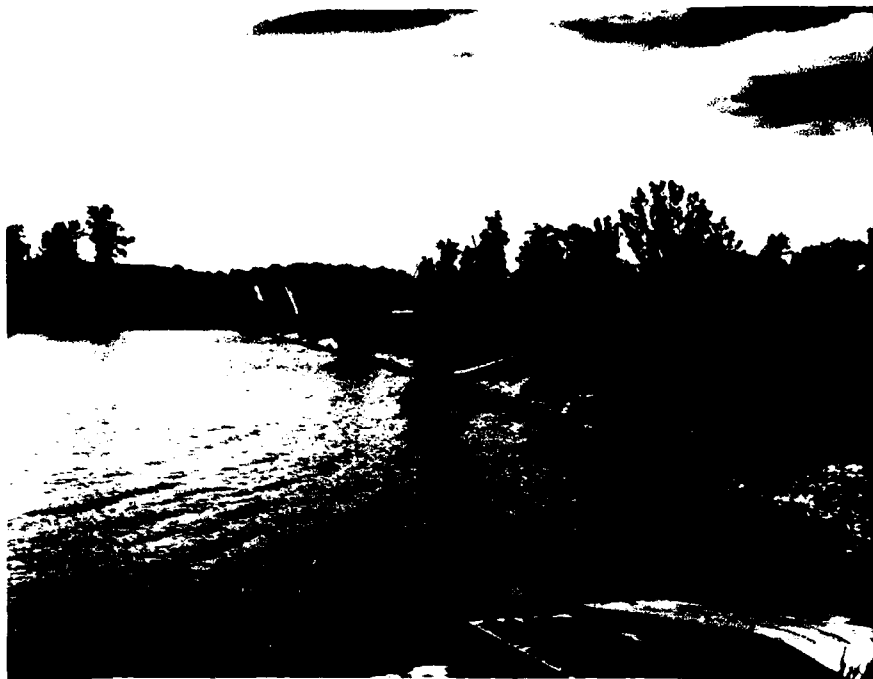
The upstream slope is protected by riprap to within 10 feet of the crown of the dam. The upstream slope above the riprap is well covered with grass. Small trees are growing along the water's edge (see Photos 3 and 5). Only slight erosion exists on the upstream slope and one erosion gully has been repaired with riprap at Station 8+85 (see Photo 6). No wavewash was present on the upstream slope. In the right abutment a concrete boat ramp has been constructed.

PHOTO 5: Growth on Upstream Slope

(1) Remove trees and brush on the upstream embankment slope. Care should be taken during removal not to destroy the existing conditions of the upstream embankment.

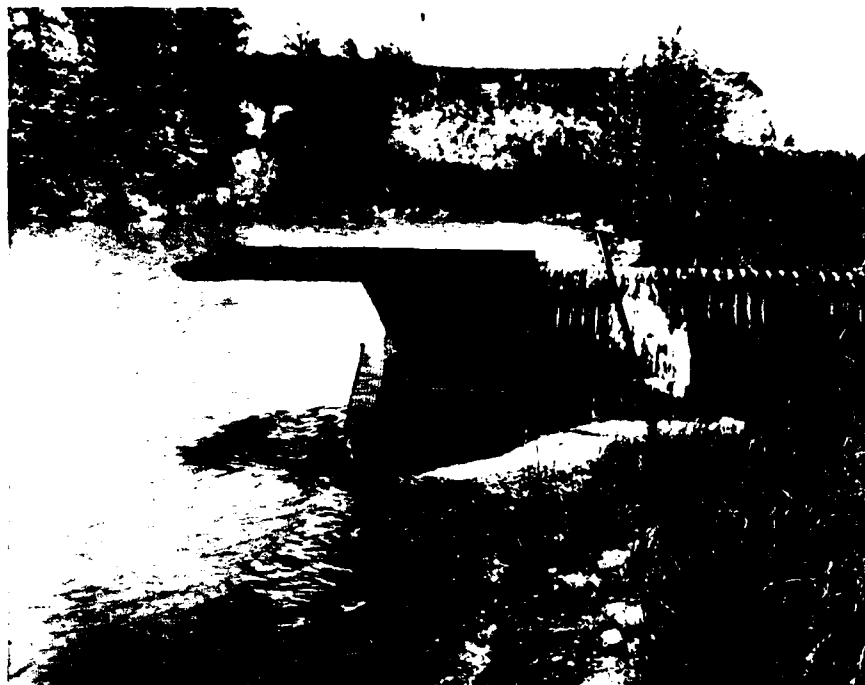
PHOTO 7: Hooded Inlet Structure

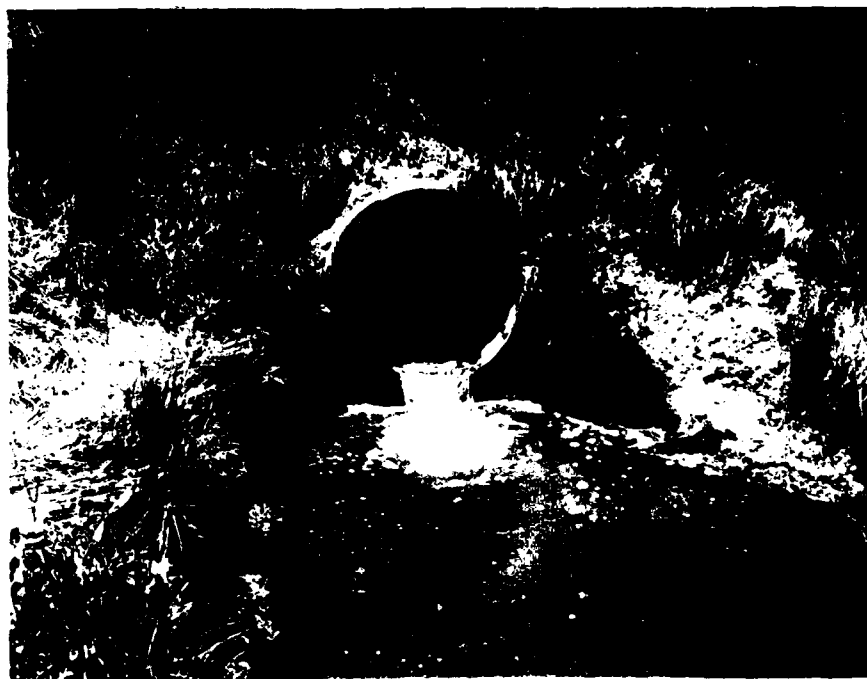
PHOTO 8: Outlet Structure and Stilling Basin

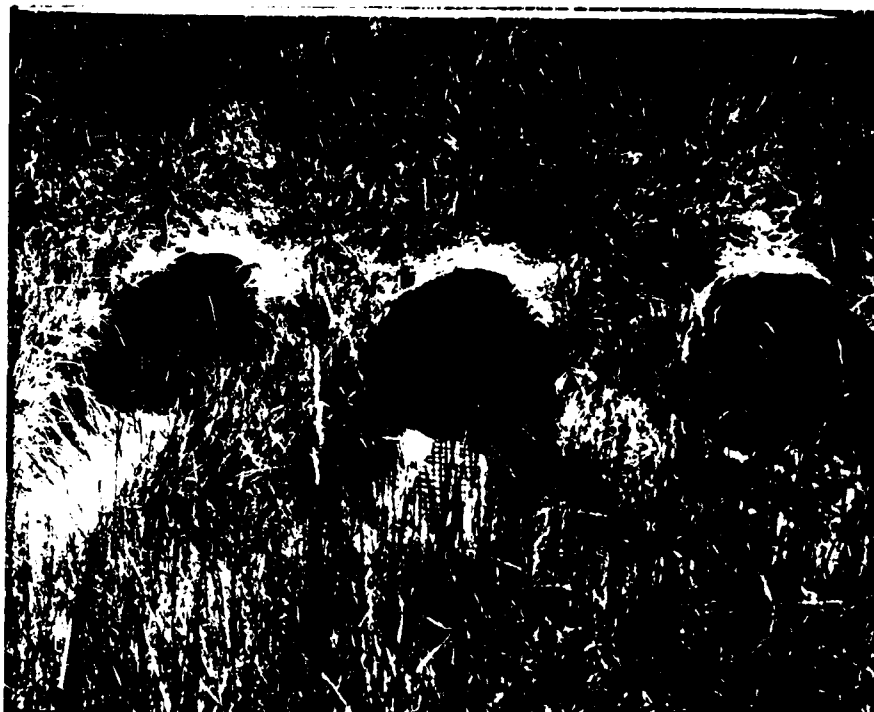
An emergency spillway exists near the left abutment of the dam. The emergency spillway consists of three uncontrolled 24-inch bituminous coated CMP which extend horizontally through the dam embankment for approximately 48 feet. The inlet invert elevation of the culverts is 461.6 N.G.V.D. and the outlet invert elevation is 461.2 N.G.V.D. The three culverts appear to be in relatively good condition (see Photo 11).

PHOTO 11: Inlets of the Culverts Composing the Emergency Spillway

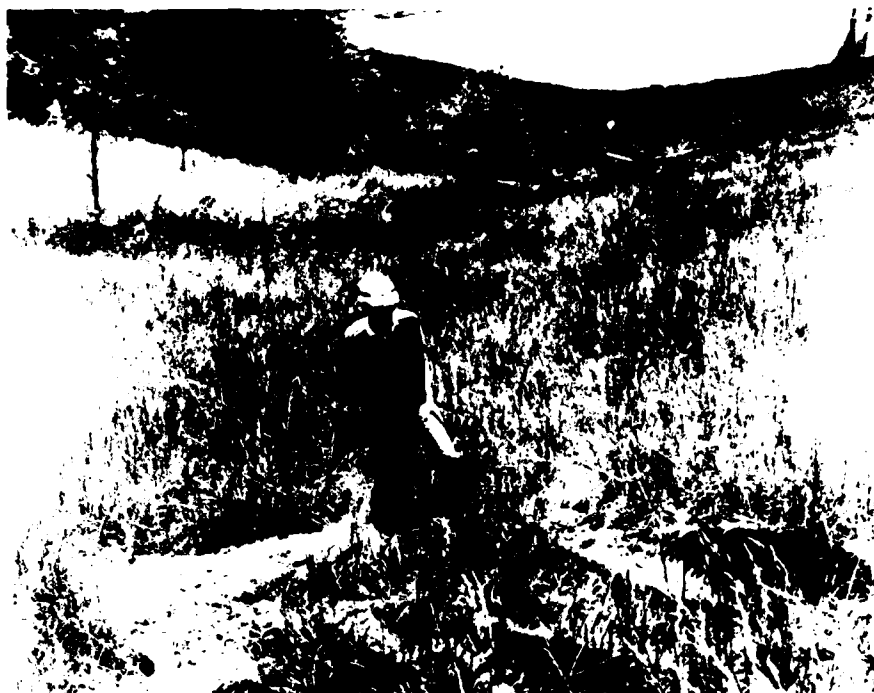
Erosion exists below the outlets (see Photos 12 and 14). The erosion gulley is approximately 10 feet long and 2 feet deep. The erosion is the result of discharge from the emergency spillway being directed onto the downstream face of the dam. There is no existing outfall channel for flow from the culverts of the emergency spillway (see Photo 13).

PHOTO 13: Emergency Spillway Outfall

(2) The downstream face of the dam below the three culverts which comprise the emergency spillway should be repaired. To prevent future erosion which could threaten the integrity of the dam, some form of erosion protection should be placed on the face of the dam below the emergency spillway or the emergency spillway should be relocated in the abutment of the dam so that discharge from the spillway can be directed away from the face of the dam.

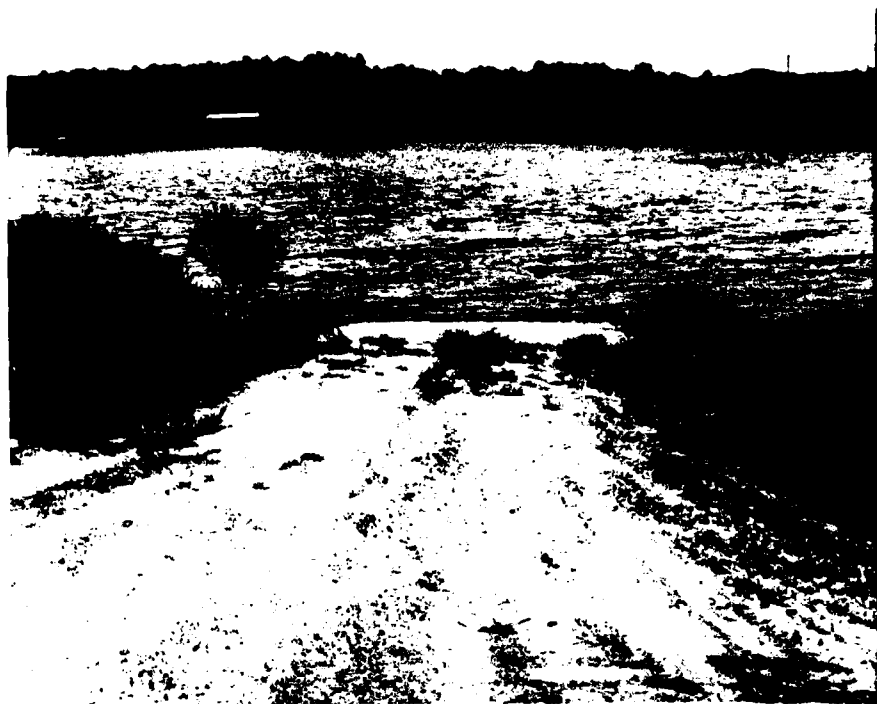
PHOTO 15: Boat Ramp In Right Abutment

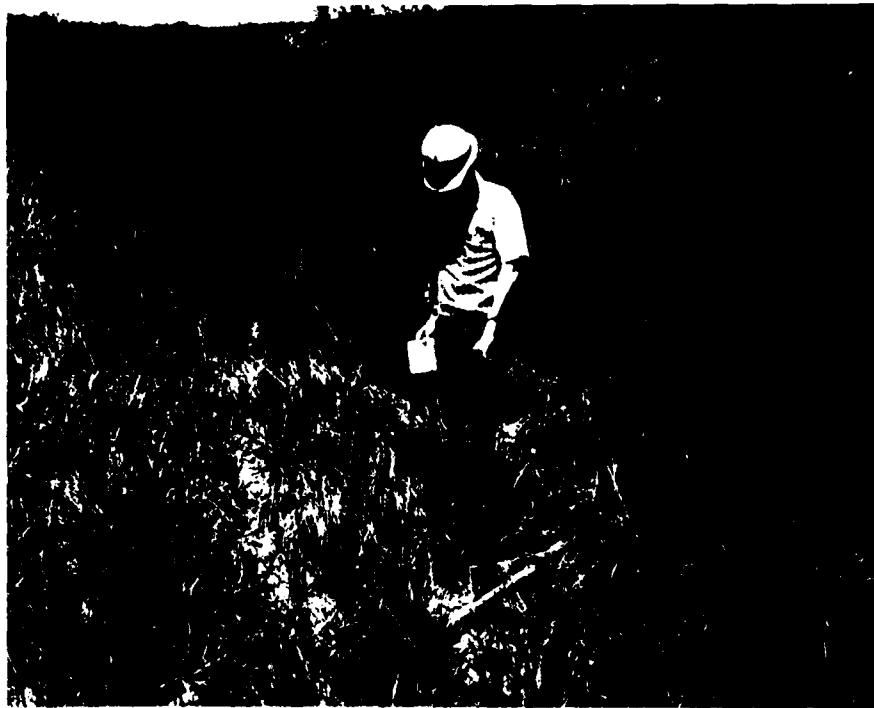
PHOTO 16: Wash Area on Downstream Slope of Left Abutment

PHOTO 17: Wash Area on Downstream Slope of Left Abutment

(3) Repair the erosion gulleys in both abutments of the downstream slope.
